Geophysical Testing Report

**White House Business Park
White House, Robertson County, TN**

July 30, 2021

Terracon Project No. 18215095

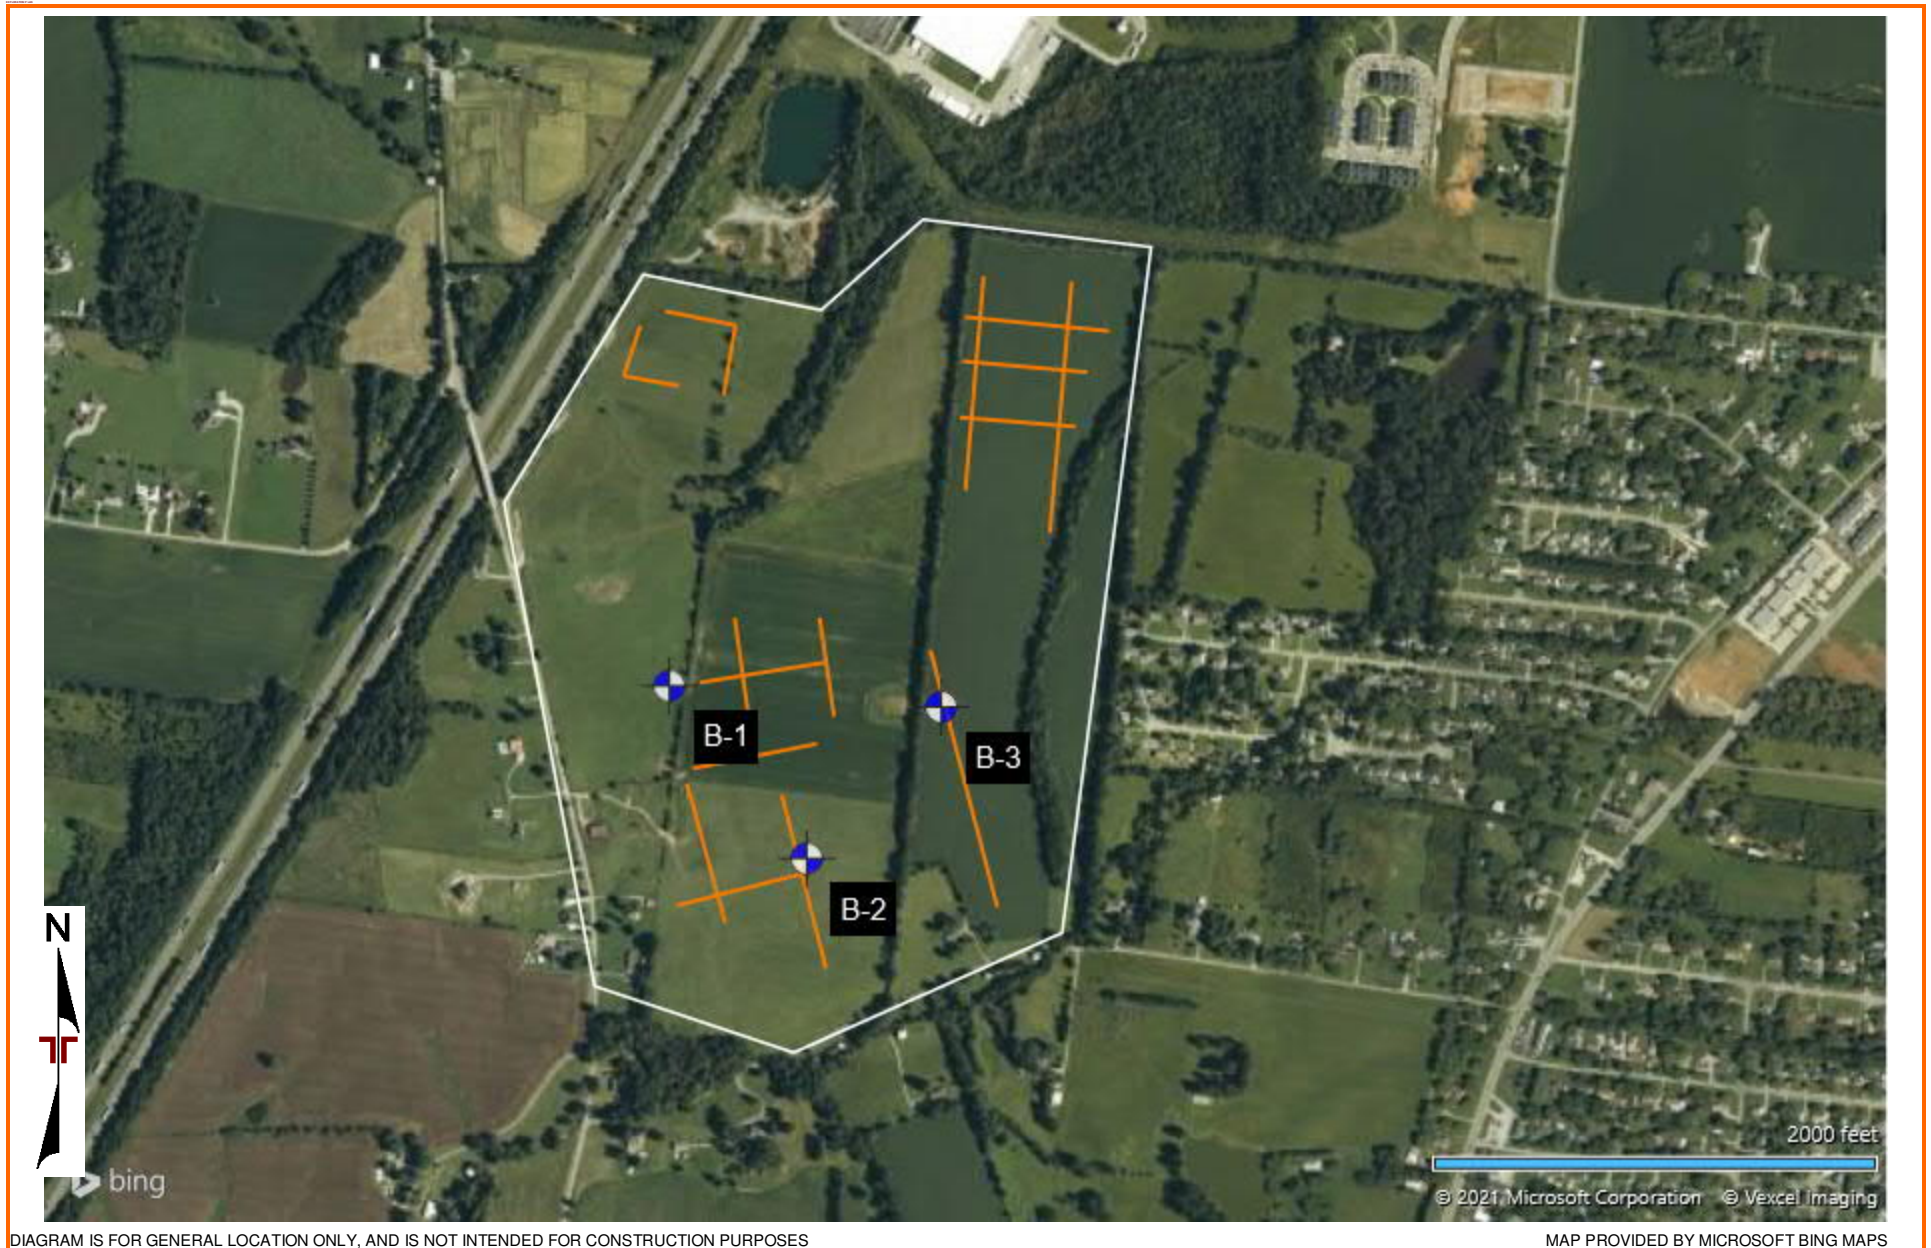
EXPLORATION PLAN

Maps showing the site and boring locations are shown in the Site Location and Exploration Plan sections, respectively. The geophysical images and boring logs are included in the **Exploration Results** section.

Borings B-1 through B-3 were drilled in the vicinity of the planned building pads, where accessible. The borings were located in the field based on our initial geophysical exploration results.

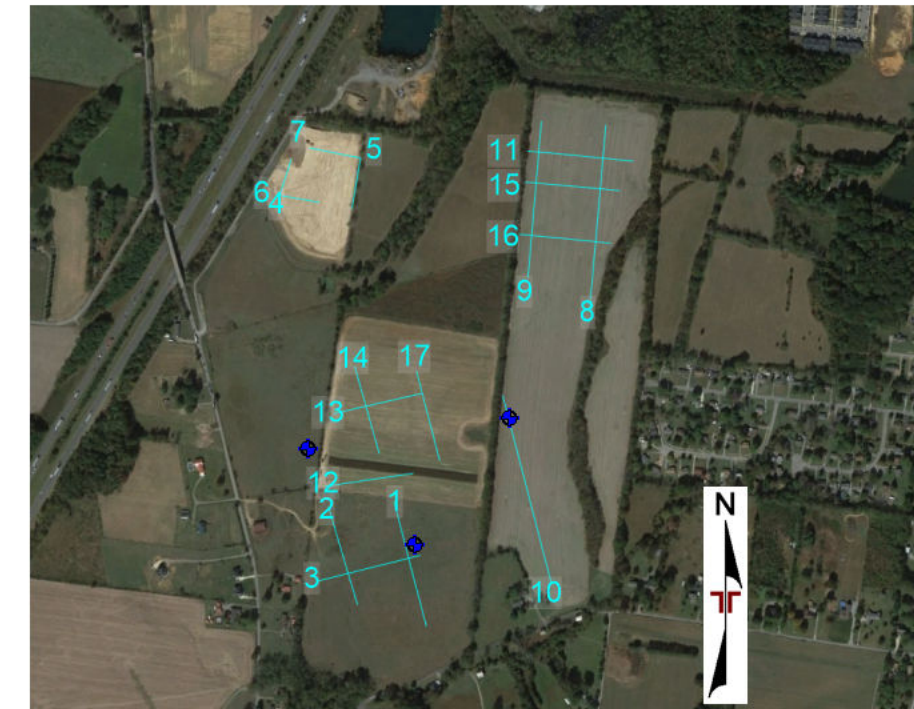
POTENTIAL KARST ANOMALY

INFERRED TOP OF ROCK SURFACE

<p>5217 Linbar Drive, Suite 309 Nashville, TN 37211</p>	Electrical Resistivity Cross-Sections - Building 1	EXHIBIT
Drawn by: NBR	Scale: 1" = 60'		White House Business Park White House, TN	2
Checked by: KJS	File Name: ERI - 1.srf			
Approved by: JEA	Date: 7/21/2021

The cross-sectional images generated from the ERT testing are displayed on Exhibits 2 through 6. The images are representations of the electrical resistivity of the subsurface materials. Resistivity is sensitive to clay content, water, sand content, and bedrock quality (clay seams and fractures). Water and clay (including fractured bedrock) produce low resistivity values (purple, blue, and dark green hues). Massive limestone units with minimal fracturing produce high resistivity values (red, orange, yellow, and light green hues). The following items were noted based upon our review of the geophysical data:

Around the 390, 500, and 550-foot distances from the start of ERI-1 and the 330-foot distance from the start of ERI-8, potential karst features were observed at the bedrock surface. It is possible that these are simply changes in material properties such as a geologic formation change or joints within the bedrock, the ground truthing exploration did not encounter specific karst features, such as soil softening or degradation of soils at depth.

Additional, deep-seated potential karst features are noted on Exhibits 2 through 6. Excavations for mass grading should be considered in these areas as deeper excavations have the potential of removing a bridging soil stratum, resulting in surface collapses. Collapses and subsurface areas of karst concern are typically remediated using inverted rock filters, a variety of subsurface grouting techniques, or a variety of building support systems.

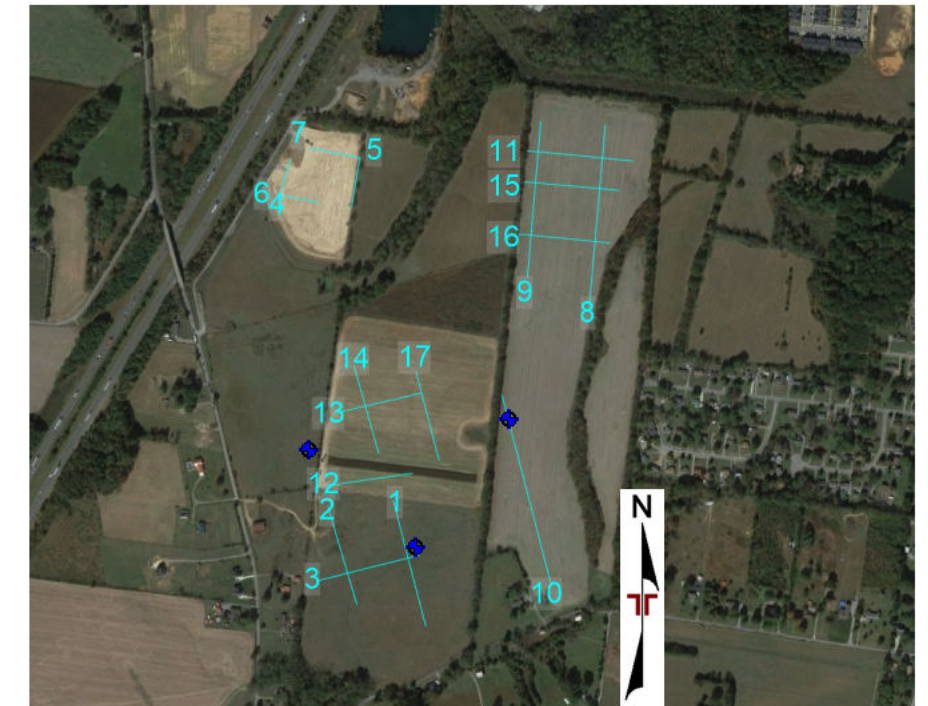
EXHIBIT

Electrical Resistivity Cross-Sections - Building 1

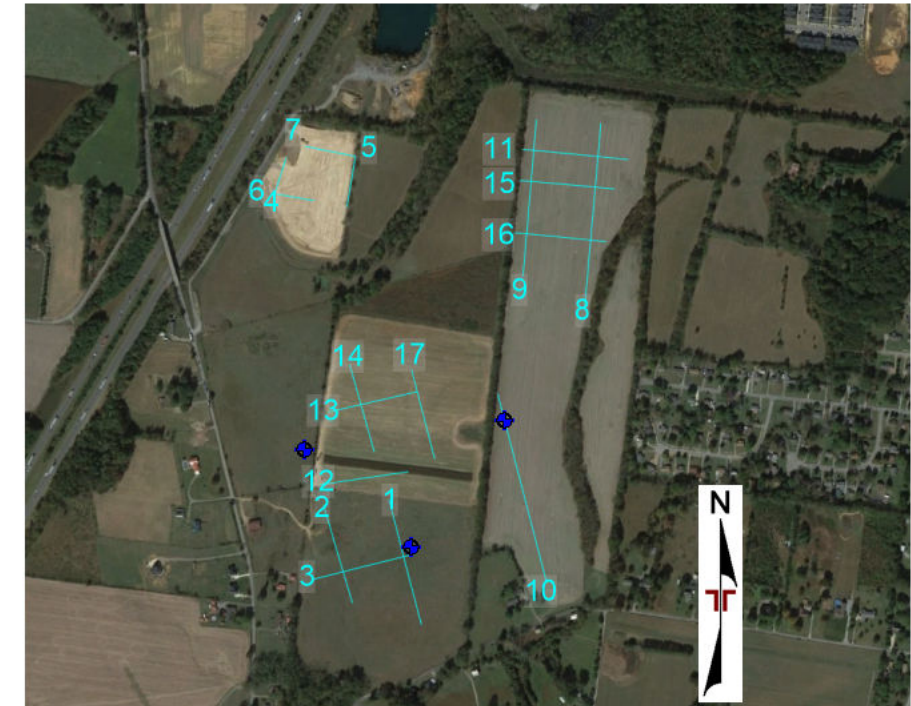
EXHIBIT

Electrical Resistivity Cross-Sections - Building 2

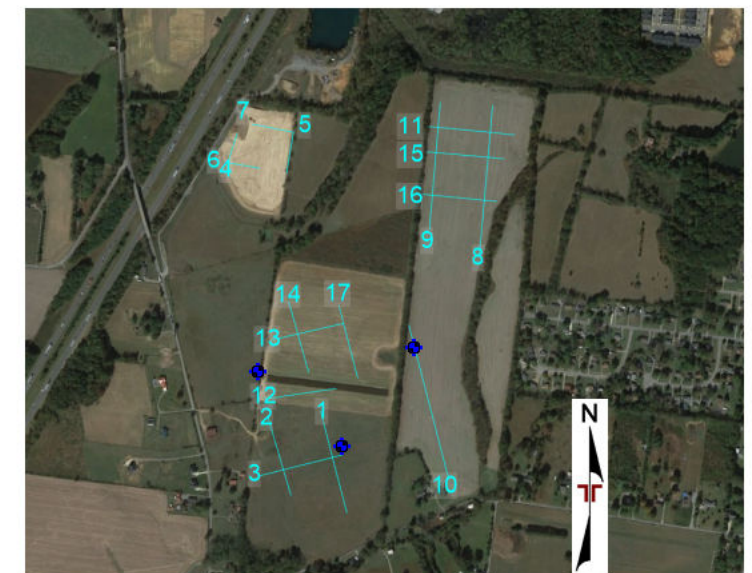
EXHIBIT

Electrical Resistivity Cross-Sections - Building 3

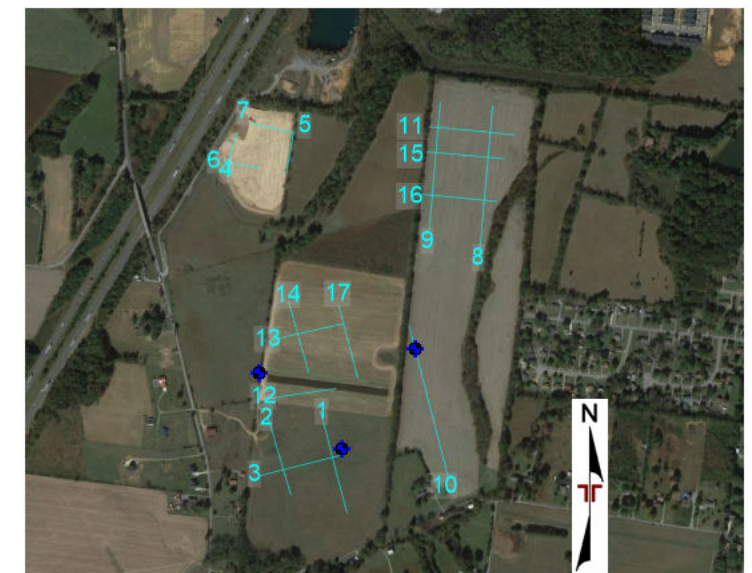
EXHIBIT

Electrical Resistivity Cross-Sections - Building 3
